# **MONTCALM COMMUNITY COLLEGE**

## **FACILITIES ASSESSMENT AND DEFERRED MAINTENANCE CAPITAL PLANNING REPORT**

**2018 UPDATE**

**MMA**  
MATHISON | MATHISON  
ARCHITECTS

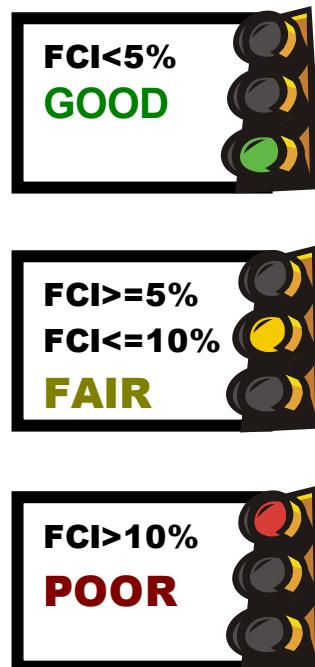
The APPA FCI Ratings, indicating the general condition of the building, are shown here along with the corresponding "traffic signals" that give a quick visual indication of the FCI rating.

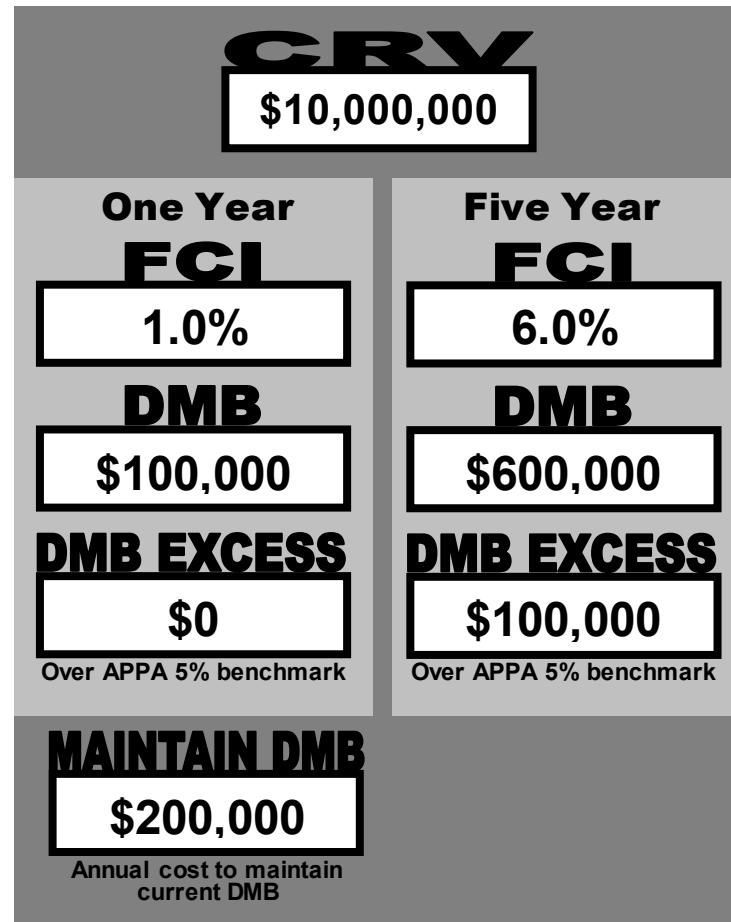
*Generic example of how the aforementioned data appears in this report*
